BDOC01 Wet Storage Damage on Pre-painted Roofing from Scaffold Support

28 November 2025

Version 1

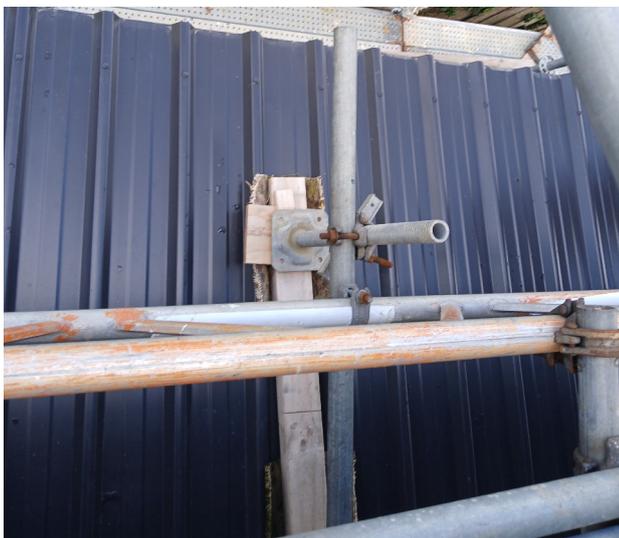
Materials or plant should never be supported from the pan

Where none of these alternatives are practical, it is the responsibility of the scaffolder and the main contractor to ensure that the scaffold support structure does not cause physical or chemical damage to the roof. Scaffold should be supported from the ribs and separated from the roof surface by a resilient, inert, non-absorbent, PH neutral, and compatible material. Carpet does not necessarily fit this criteria.

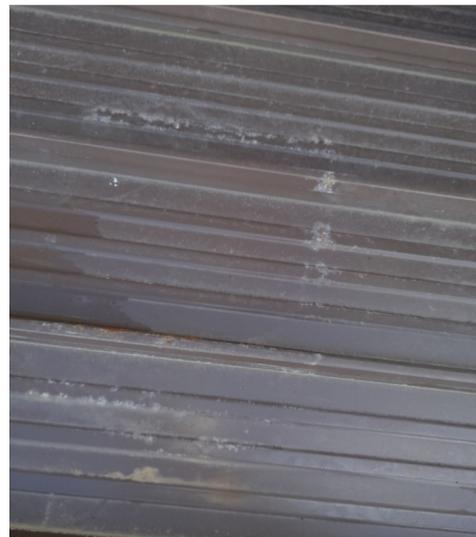
Typical corrosion failure from scaffold support on pans

When air is excluded from the surface of metallic coated or pre-painted metal roofing in wet conditions, bulky, volatile and non-adherent compounds are formed on the metallic surface. This results in blistering of the paint and the appearance of white powdery corrosion compounds on the paint surface. The speed in which this happen cannot be predicted, as it is dependent on numerous inter-related influences including the nature of the entrapping material, temperature, time of wetness, and ambient environment.

There is no stipulated "safe" period of exposure, it is up to the main contractor to minimise time of exposure and monitor the condition of the under-lying material on an ongoing basis. Localised evidence of white powdery deposits and paint blistering on specific areas of roof upon which scaffolding has been staged, is clear evidence of wet storage corrosion.
