## **BU02 Over-Saturation of Underlay**

11 November 2025

Version 1

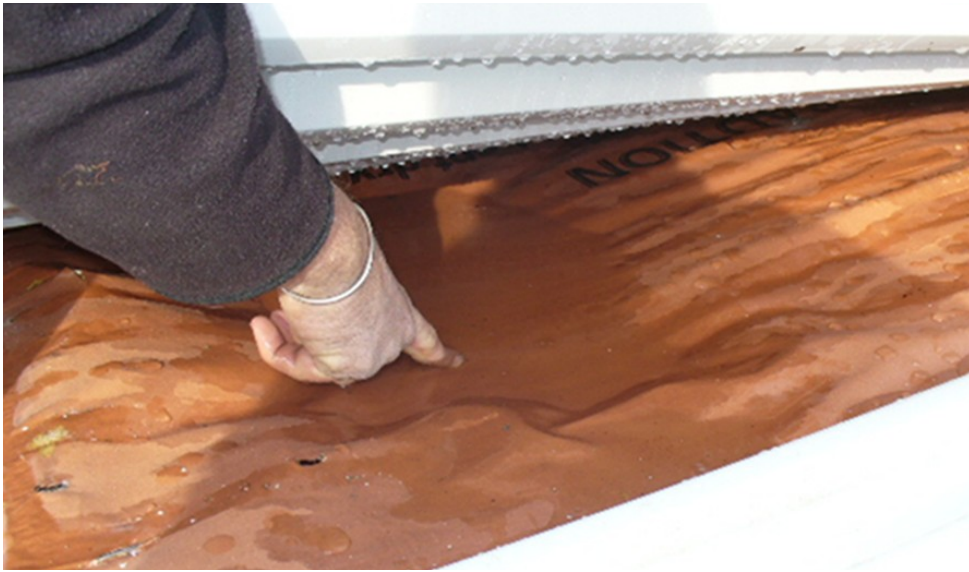
*Once all absorbent surfaces are saturated, condensation can pool on the upper surface of the roofing underlay. It is the result of a gross imbalance between water vapour entering the ceiling cavity and water vapour escaping.*

If excessive condensation is experienced in the ceiling space after moisture levels in construction materials have stabilised, it is necessary to ensure that the amount of moisture exiting the ceiling space equals the moisture which enters.

Ventilation is sometimes necessary to achieve this and will benefit most roof assemblies. However, if the core problem is excessive ground or internal water entering the roof space, ventilation may only make it worse. The solution in such cases is to address the moisture problem at the source. Unbalanced HRV systems can also create a problem by causing a pressure imbalance between the ceiling space and dwelling areas.

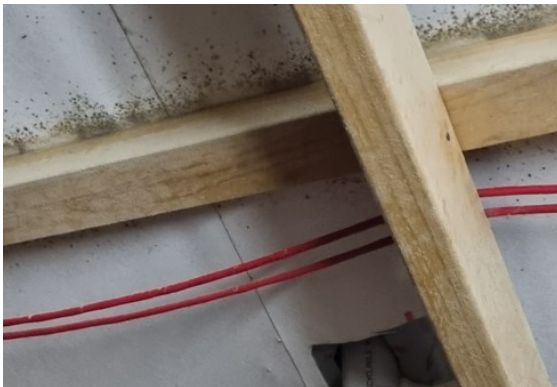
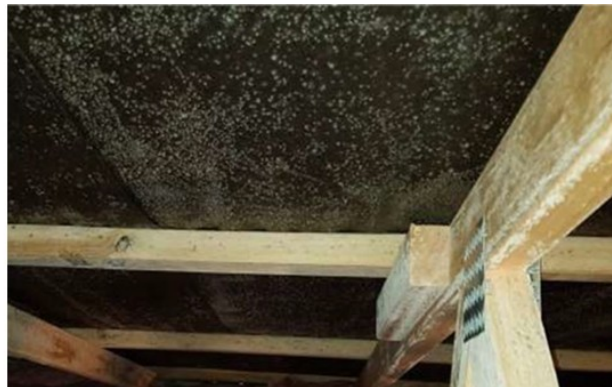
*Prolonged wetness of underlay and structure can result in mould growth. This is often initiated in the post-enclosure building stages of a contract.*
