## **BU02 Over-Saturation of Underlay**

11 November 2025

Version 1

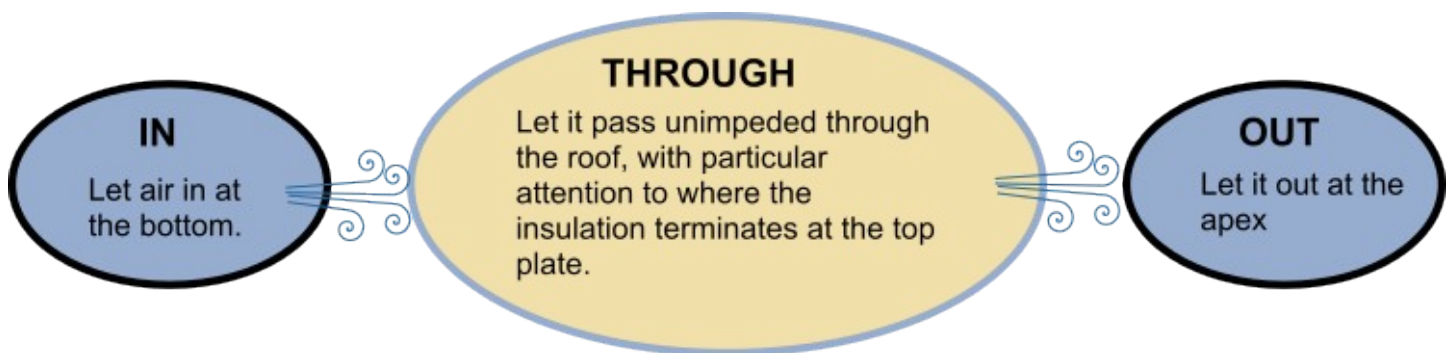
The rule for ventilation is: **In, Through, Out.**

That is the normal passage of water vapour on a still night. It may be reversed due to wind conditions, but the principle remains the same.
